## Thermo Active Building Systems(TABS) - Performance in practice and possibilities for optimization

# Thermo Active Building Systems (TABS) - Performance in practice and possibilities for optimization

DTU Byg-Sagsrapport SR-16-04 (DK)  
Marts 2016

Byg Sagsrapport SR 16-04 (DK)

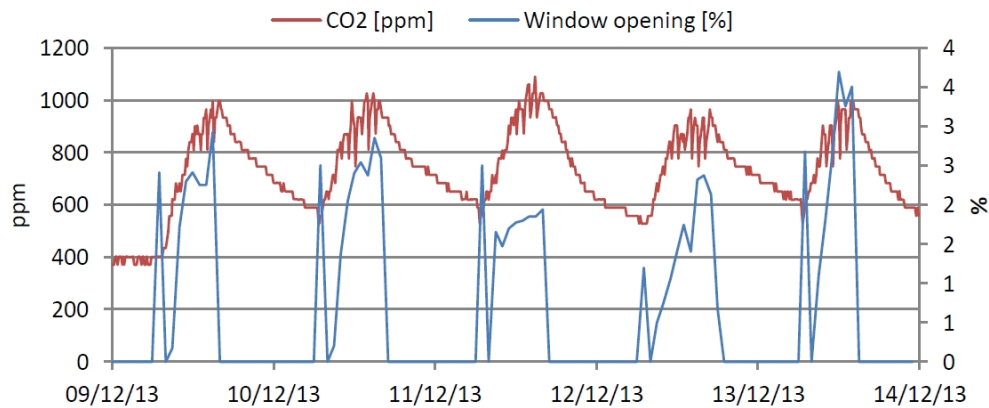
Figure 2 – The natural ventilation strategy in Viborg Town Hall and corresponding CO<sub>2</sub> concentration – south west open plan office on the 2<sup>nd</sup> floor

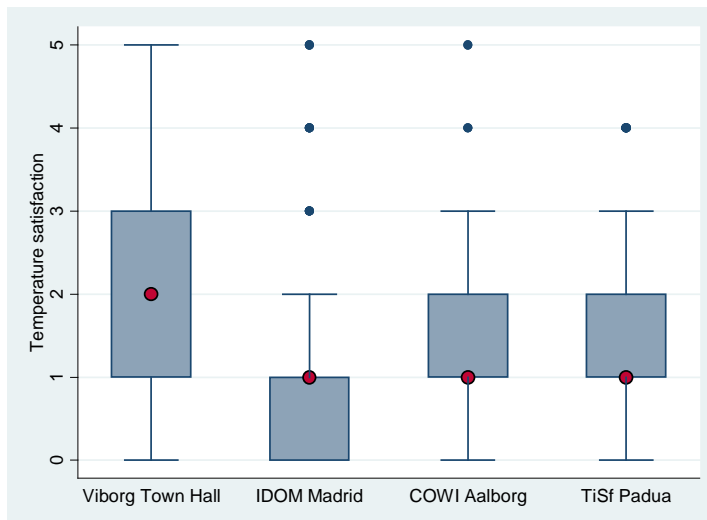
Figure 3 – Box plot of temperature satisfaction for all surveyed buildings (on vertical axis: 0 = "Clearly satisfied", 1 = "Satisfied", 2 = "Just satisfied", 3 = "Just dissatisfied", 4 = "Dissatisfied", 5 = "Clearly dissatisfied")

Figure 3 shows a box plot of temperature satisfaction from all surveyed buildings. Median temperature satisfaction was in the range of the scale expressing satisfaction with the conditions. When considering whole interquartile range, the highest satisfaction was expressed by respondents in IDOM building in Madrid. Viborg Town hall had the lowest satisfaction rate with median of 2 and interquartile range of (1, 3) on the satisfaction scale. This corresponds well with results of physical measurements.

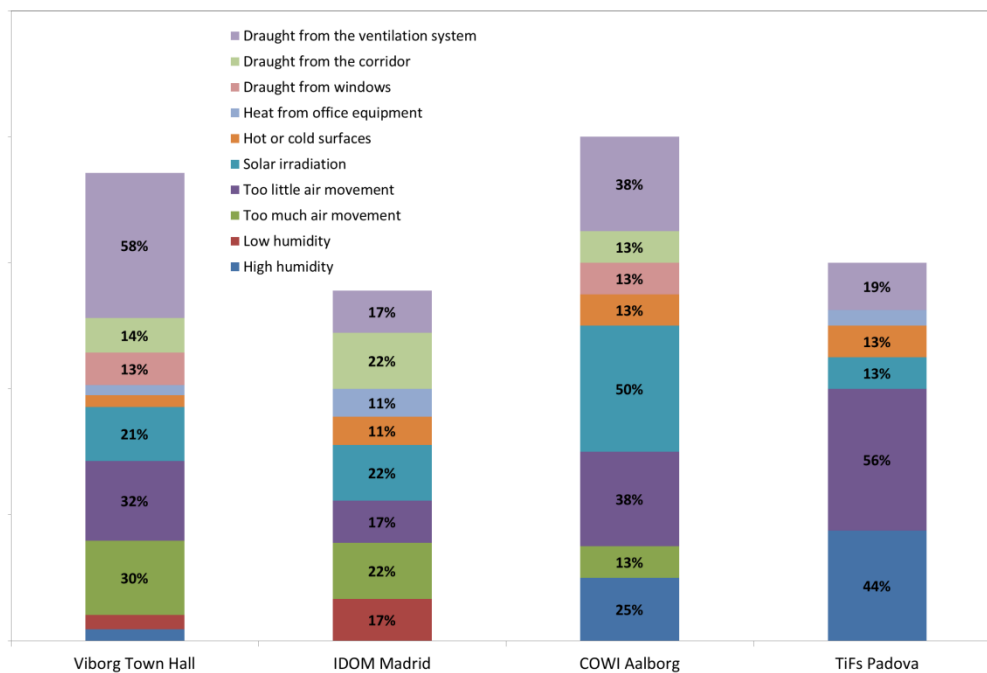
Figure 4 – Sources of thermal discomfort in surveyed buildings – value labels indicate percentage of respondents dissatisfied with thermal conditions that indicated particular source of discomfort

Figure 4 illustrates distribution of sources of discomfort in surveyed buildings. The percentage in the figure represents percentage of respondents that were dissatisfied with thermal conditions in the particular building.

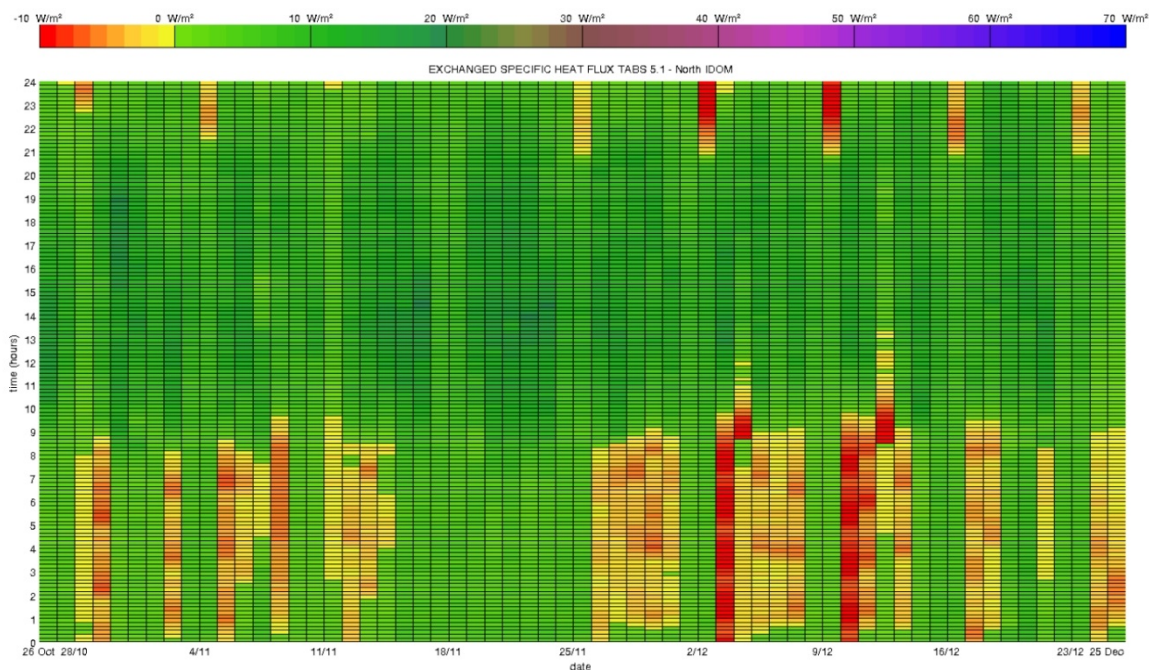
Figure 5 - Exchanged specific heat flux by TABS ( $\text{W/m}^2$ ) in northern office space in IDOM Madrid during winter; positive values indicate cooling and negative values heating of the space

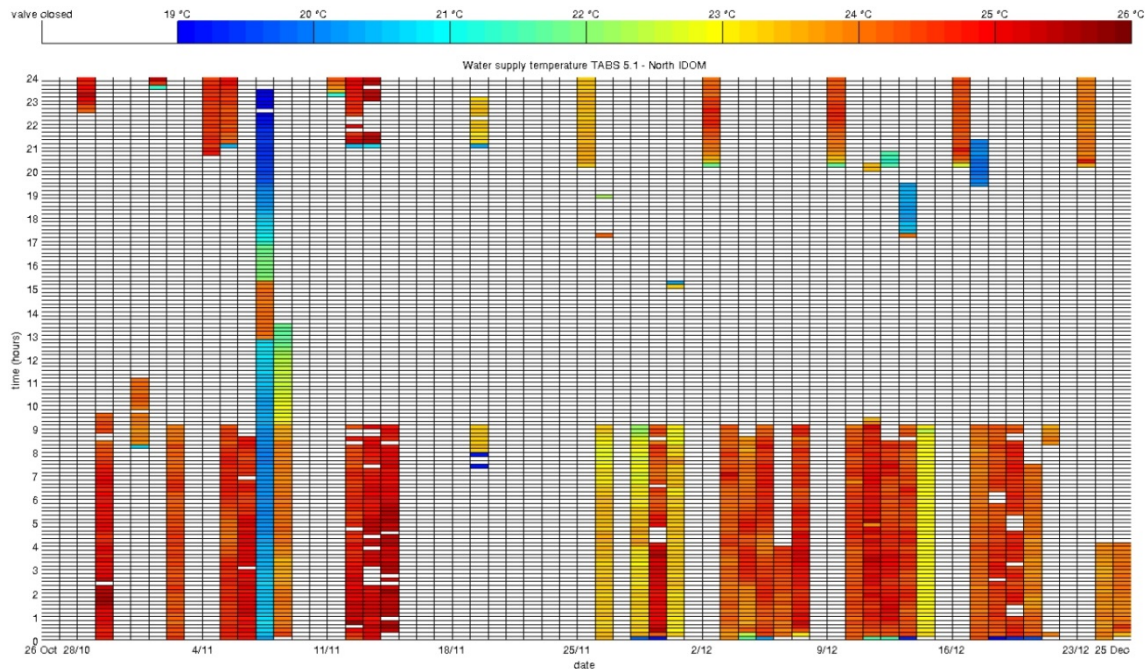
Figure 6 – TABS supply water temperature (°C) in northern office space in IDOM Madrid during winter; white areas indicate periods with no water circulation through the TABS in the zone

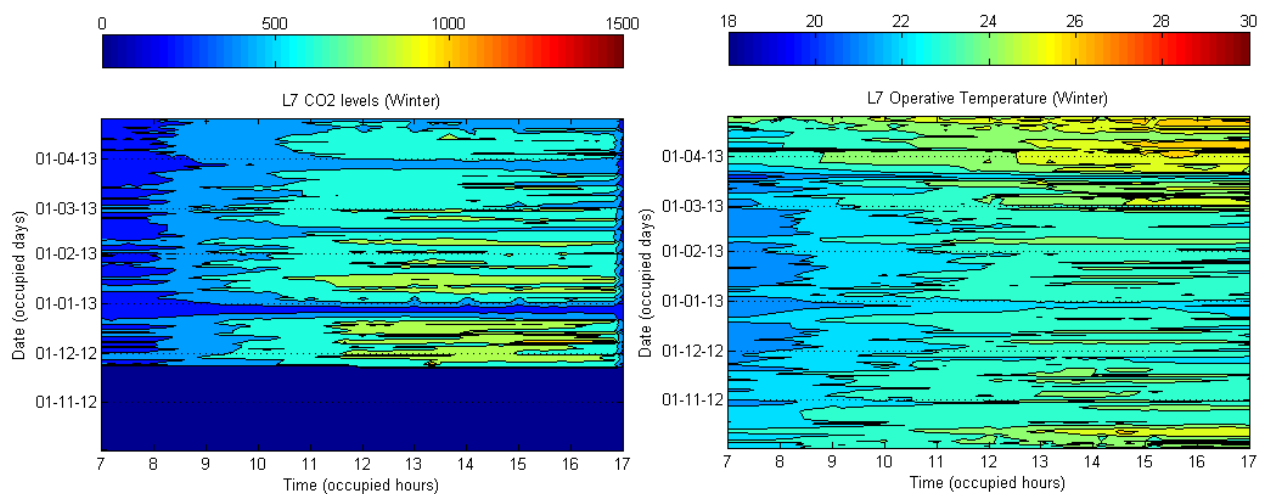
Figure 7 – Left: CO<sub>2</sub> concentration (ppm) and Right: operative temperature (°C) in south-west open plan office space in Viborg Town Hall during occupied hours

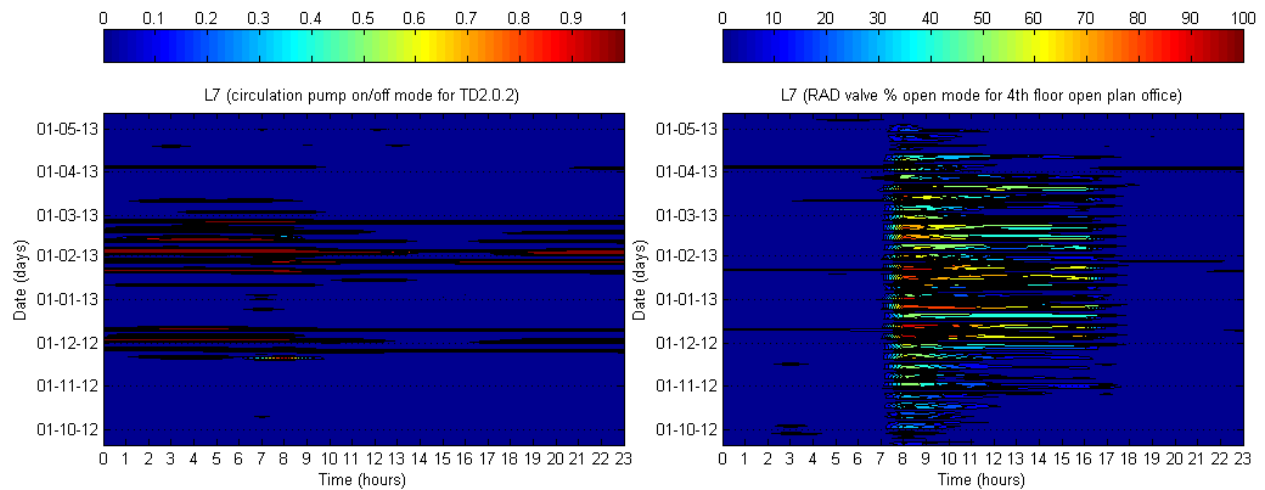
Figure 8 – Left: TABS circulation pump operation and Right: operation mode of the motorized valve on convectors under windows in south-west open plan office space in Viborg Town Hall

Above mentioned results, together with results from the occupancy survey, which showed large percentage of respondents dissatisfied with draught caused by ventilation, indicate that control strategy for thermal environment in the building deserved some optimization.

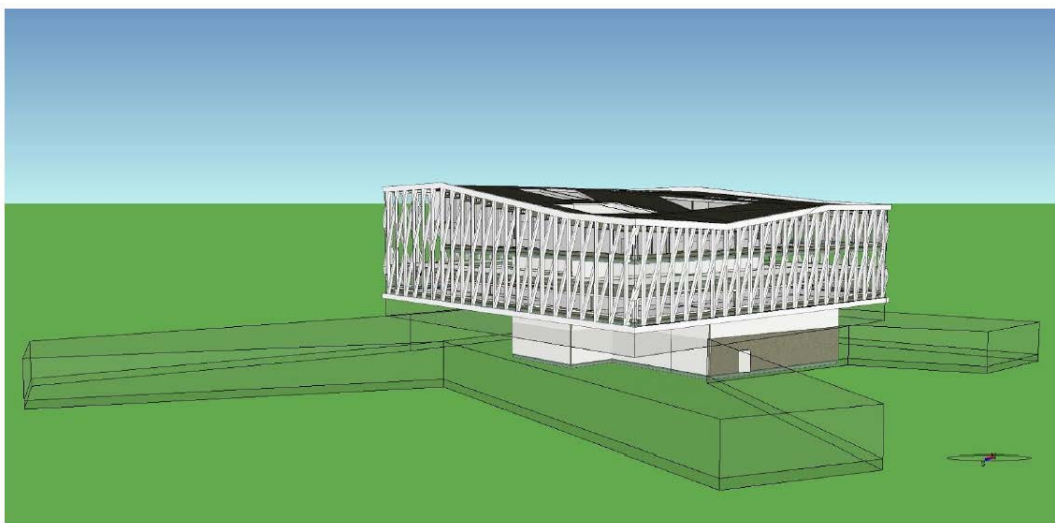
Figure 9 – Model of Viborg Town Hall in building performance simulation tool IDA ICE

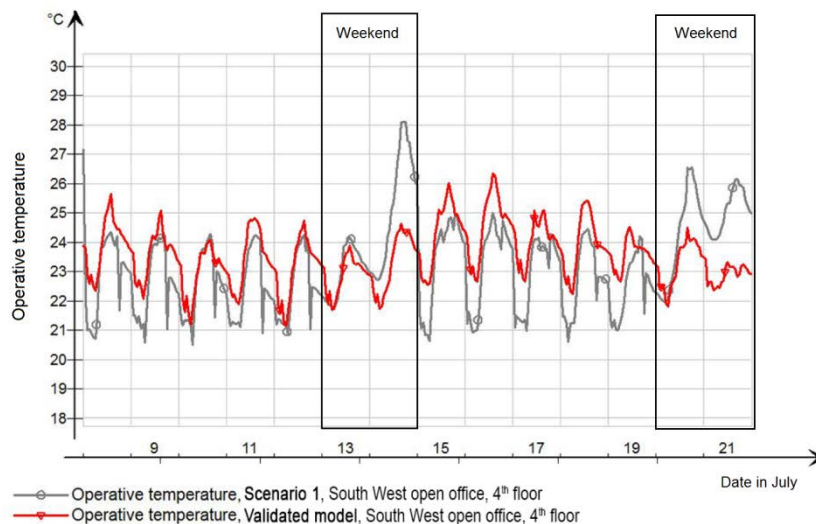
Figure 10 - Comparison of operative temperatures in validated model (reference) and optimization Scenario 1 at open plan office at 4<sup>th</sup> floor oriented towards south west (14 days from 8 July till 21 July)

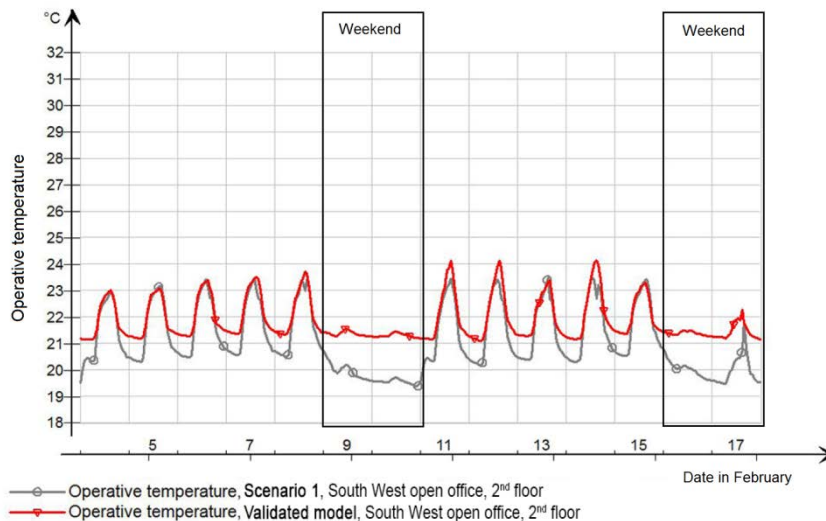
Figure 11 - Comparison of operative temperatures in validated model (reference) and optimization Scenario 1 at open plan office at 2<sup>nd</sup> floor oriented towards south west (14 days from 4 Feb. till 17 Feb.)

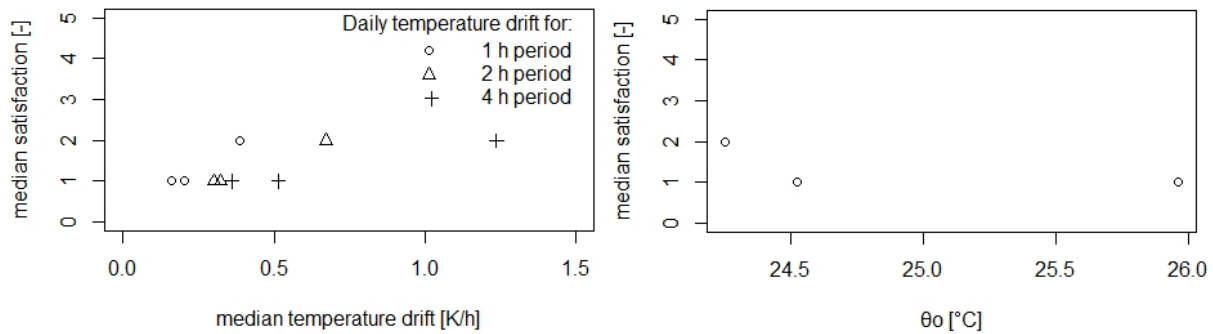
Figure 3. (Left) Relation between daily temperature drift and temperature satisfaction from all investigated buildings, (Right) Relation between daily mean operative temperature and temperature satisfaction from all investigated buildings

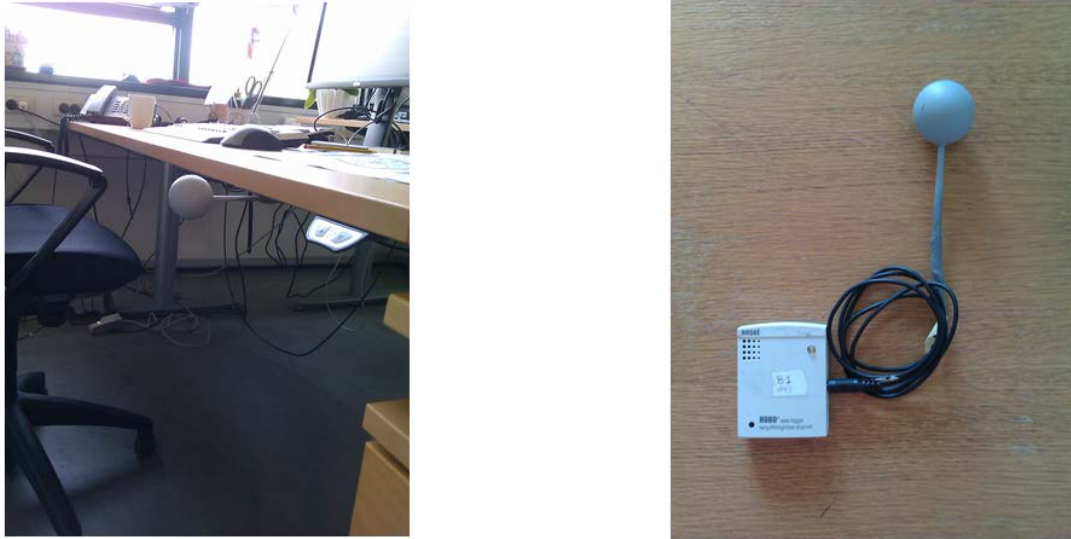
**Figure 1 - (Left) Illustrative placement of an operative temperature sensor at a workplace, (Right) A set of grey sphere-shaped sensor and data logger**

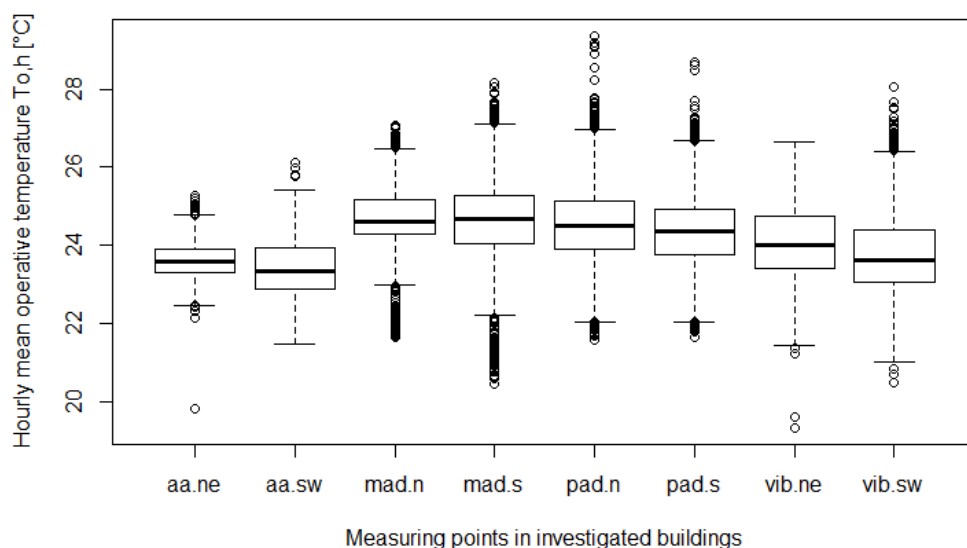
**Figure 2 – Measured mean operative temperatures in investigated buildings, measuring points are abbreviated as follows: first two letters – building: aa – COWI Aalborg, mad – IDOM Madrid, pad – TiSF Padua, vib – Town Hall Viborg; second two letters – orientation: n – North, ne – North-east, s – South, sw – South-west**

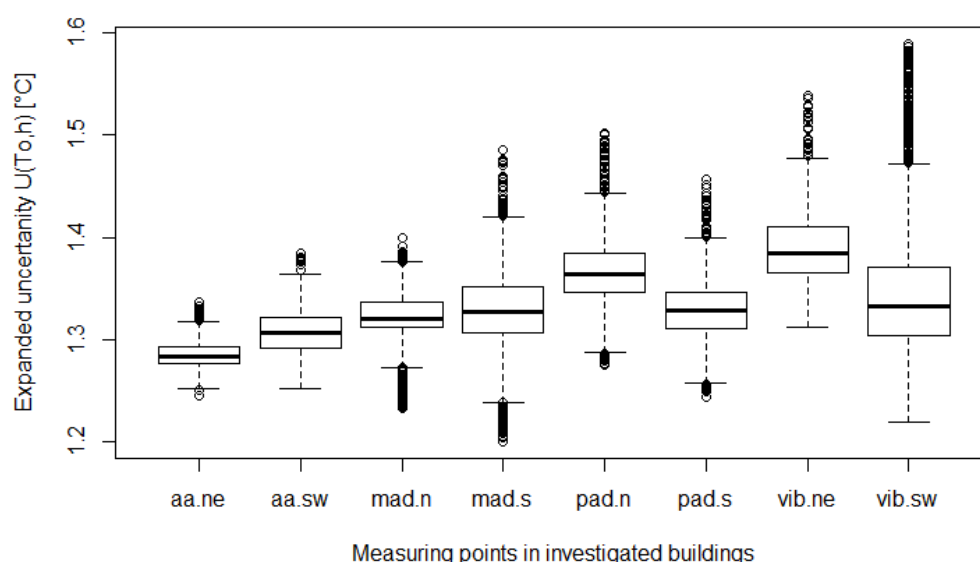
**Figure 3 – Expanded uncertainty of hourly mean operative temperature in investigated buildings, abbreviation of measurement points is identical to Figure 2**
